2012 USA Pro-Cycle Challenge Pre/Post Race  
Resource Condition Assessment  
Photo Point Monitoring – Summary Report

Prepared by Deonne VanderWoude and Ann Lezberg  
Resource Monitoring Technicians  
City of Boulder  
Open Space and Mountain Parks Department  
September 2012

# 2012 USA Pro-Cycle Challenge Pre/Post Race Resource Condition Assessment – Summary Report

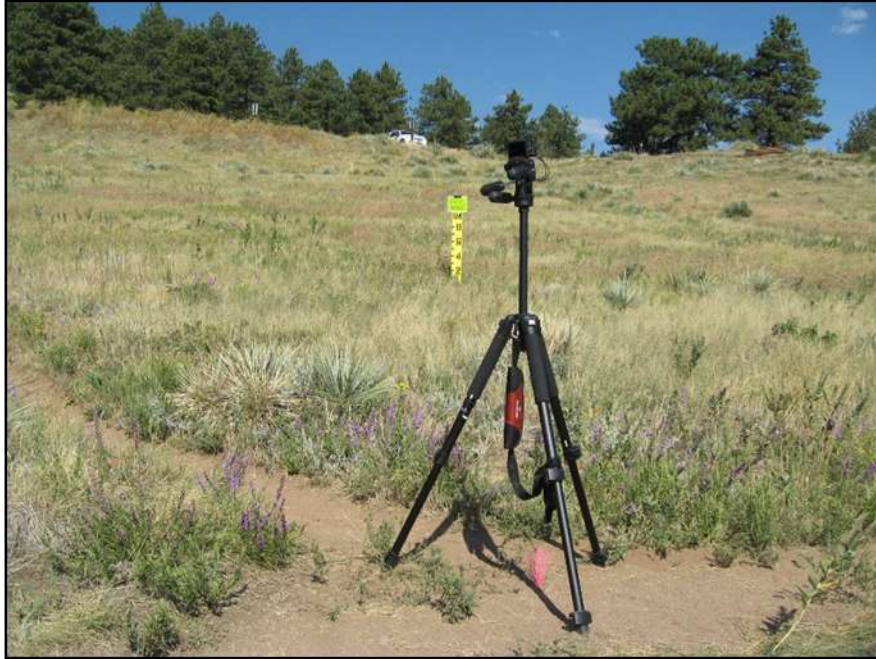
**Figure 2.** Typical photo set-up showing the tripod, meter-post and ground to horizon view

Staff used a tripod-mounted digital camera to capture a landscape view, centered on a yellow meter-post, to document location and scale of each of the photographs (**Figure 2**). Settings for the tripod and camera along with measurements for the placement of the post were recorded during the pre-race photo interval and then used again for each of the following intervals.

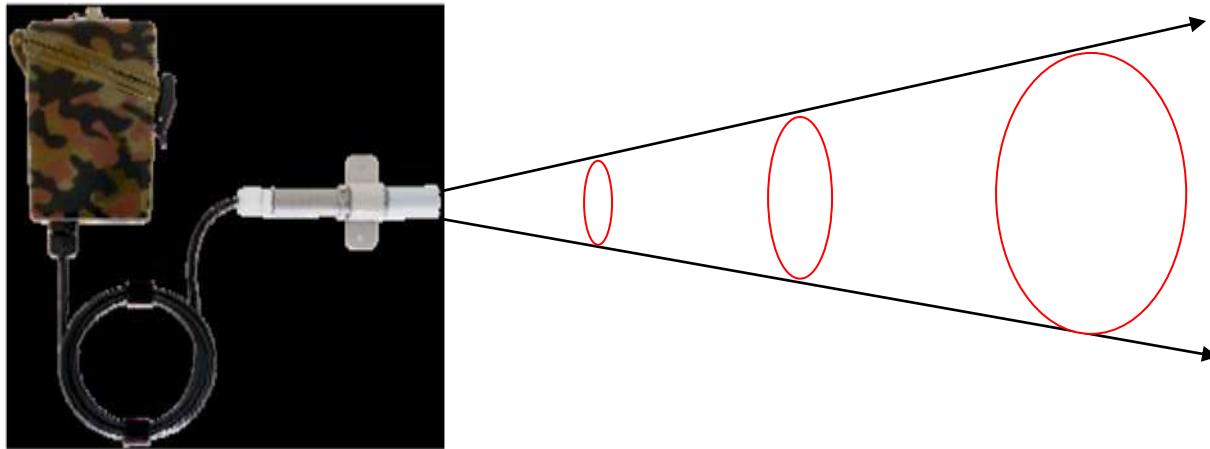
**Figure 3.** TRAFx Generation III monitor showing the beam's detection zone variability at different distances from scope to trail

The TRAFx Generation III monitor (**Figure 3**) is a one-piece unit consisting of an infrared transmitter and an infrared receiver (housed together). The transmitter emits an infrared beam across the trail. When this beam is broken, the receiver records one “count”. Staff placed a TRAFx monitor on the Viewpoint Trail (open for entering and exiting the race) and on the Flagstaff Trail (open for exiting only) near photo point 2 and 5 respectively. The monitors run continuously and were in operation between 8/18/12 and 9/5/12 to give a relative idea of the level of visitation at the monitored locations pre, post and during the race.

Distance from IR scope to trail	2m (6.5 ft.)	4m (13 ft.)	6m (20 ft.)
Diameter of detection zone	0.3m (1 ft.)	0.7m (2.3 ft.)	1.0m (3.3 ft.)

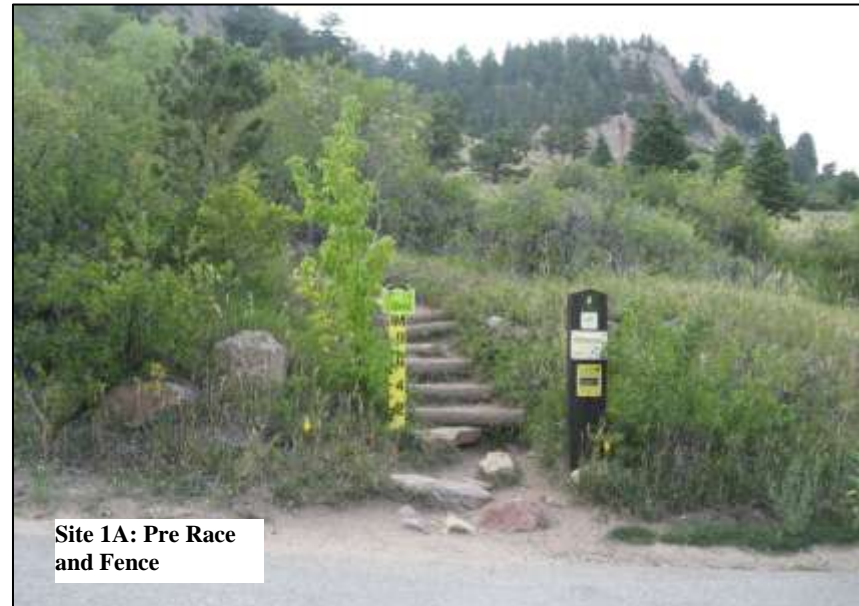
Site 1A: Pre Race  
and Fence

Results: No noticeable effect from fence placement or spectator activity

Note(s): Start of Flagstaff Mt. race finish

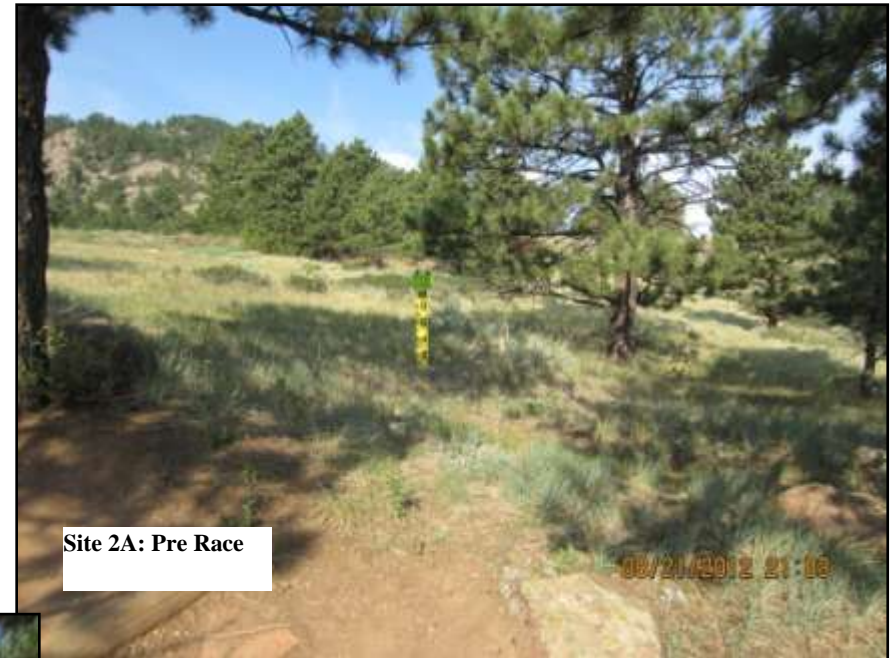
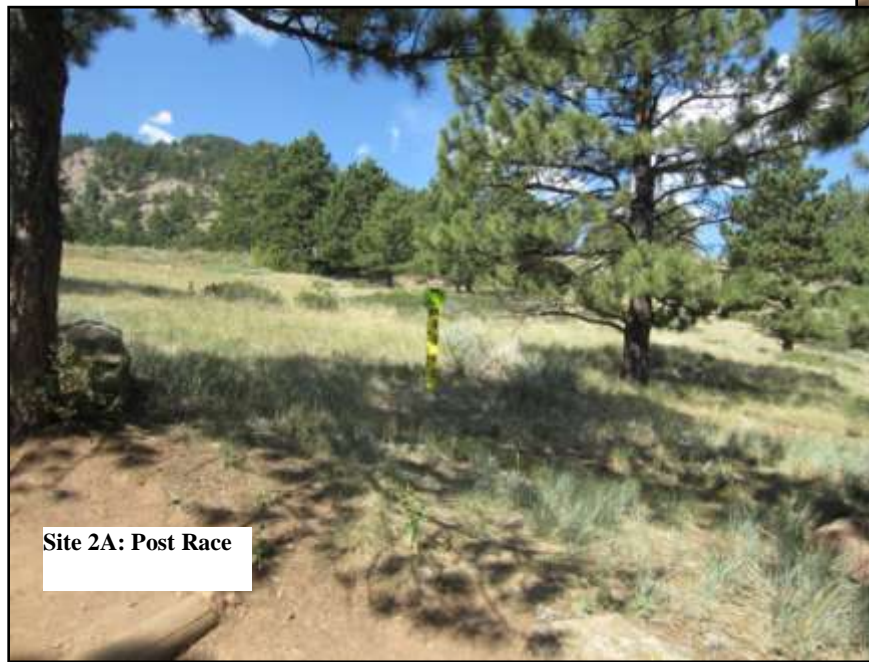
## **2012 USA Pro-Cycle Challenge - Site ID 2A Center**

Results: No noticeable effect from spectator activity

Note(s): Panorama Point viewing area

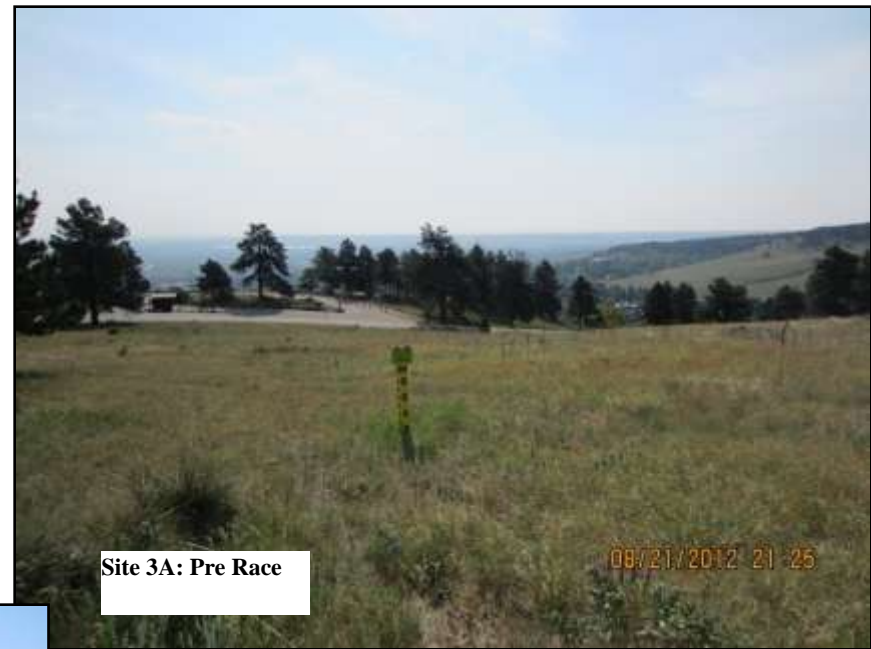
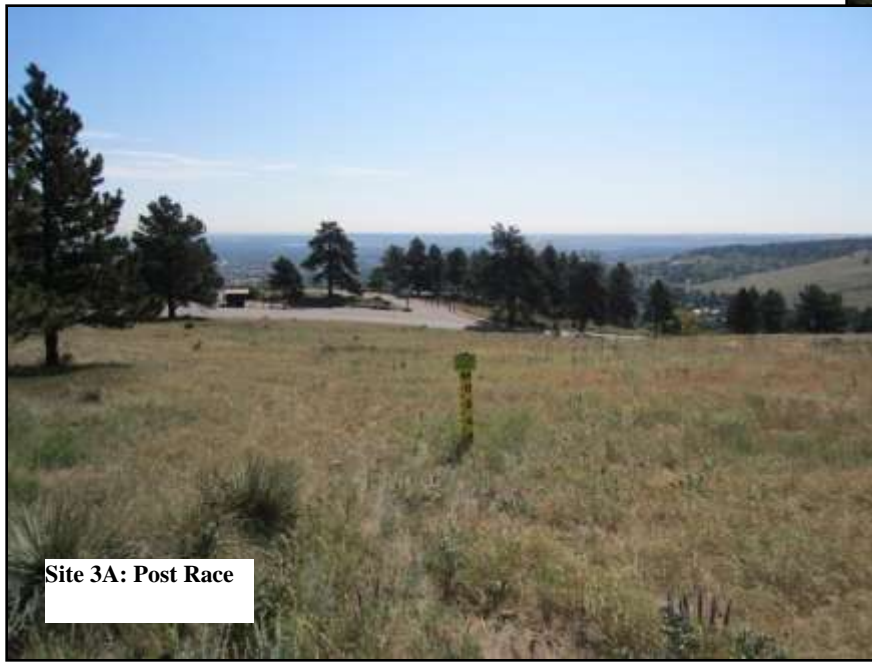
## 2012 USA Pro-Cycle Challenge - Site ID 3A Center

Results: No noticeable effect from spectator activity

Note(s): Halfway House meadow viewing area

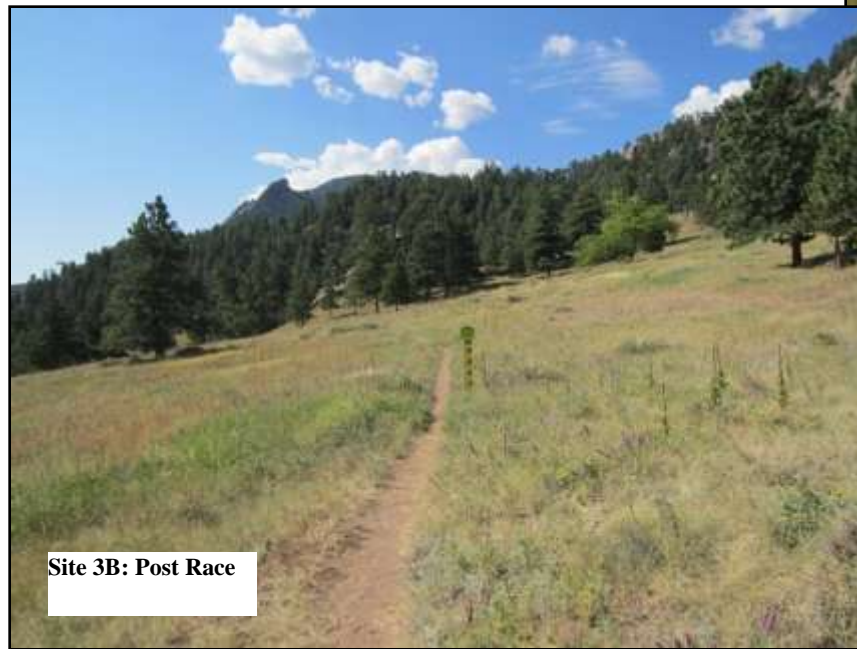
Results: No noticeable effect from spectator activity

Note(s): Halfway House meadow viewing area

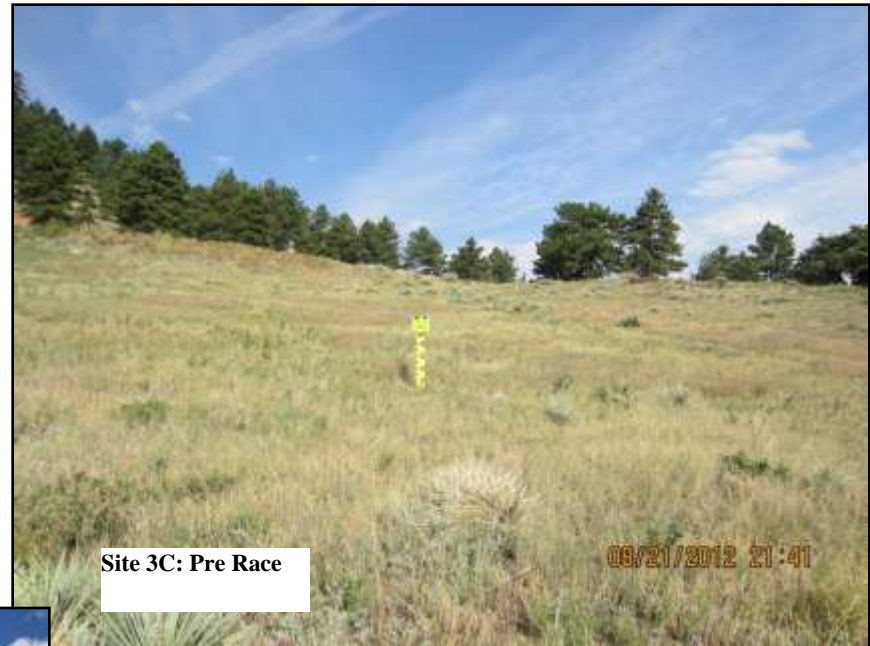
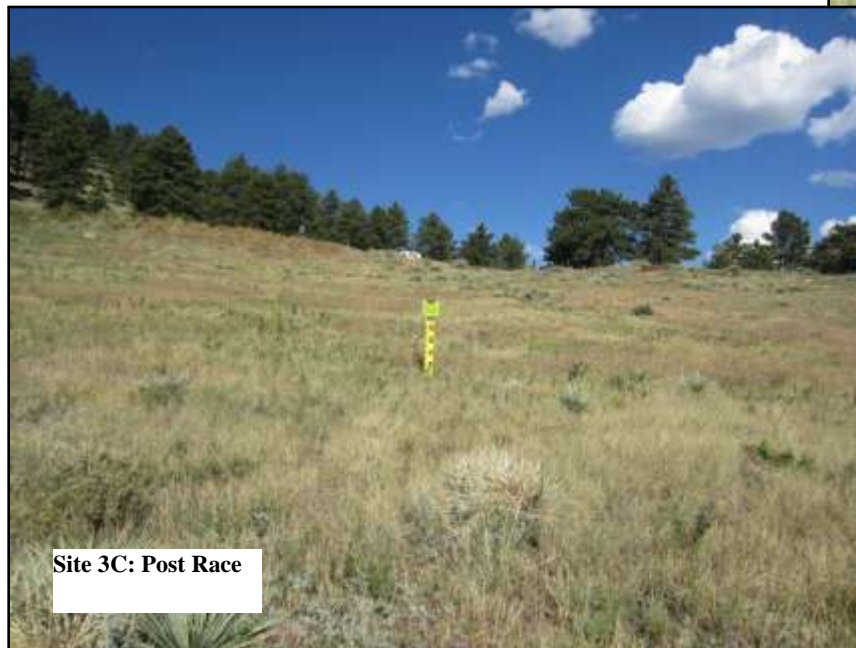
Results: No noticeable effect from spectator activity

Note(s): Halfway House meadow viewing area

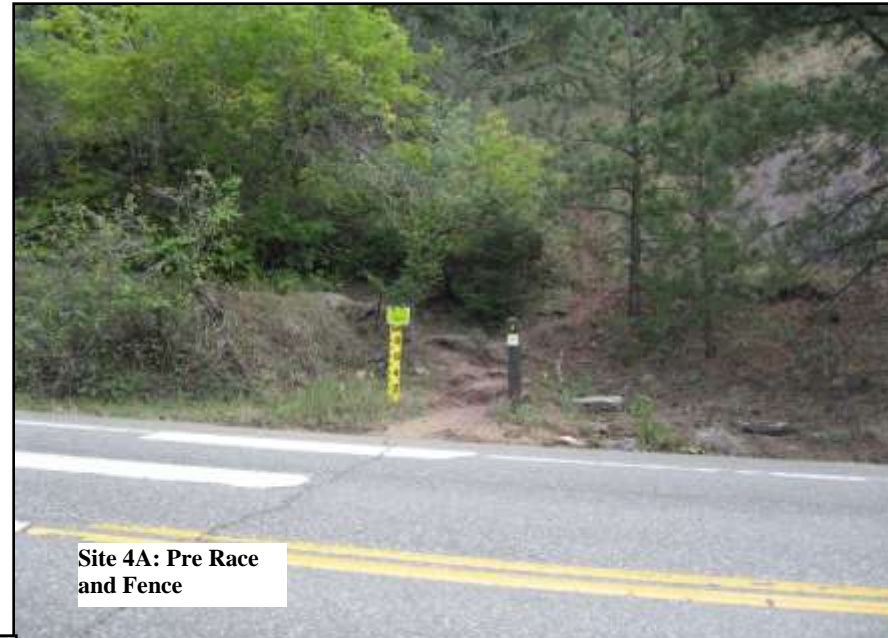
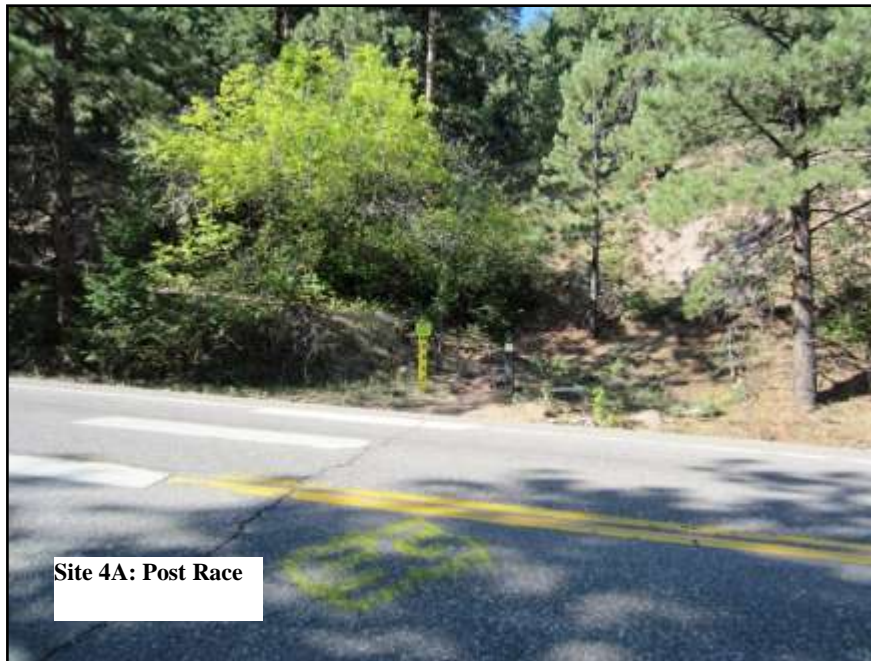
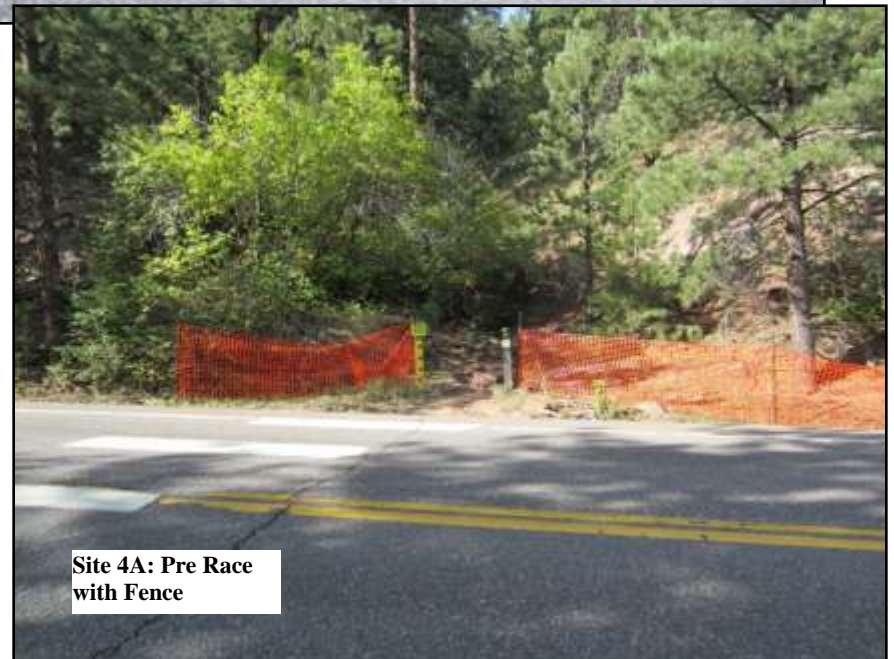
## 2012 USA Pro-Cycle Challenge - Site ID 4A Center

Results: No noticeable effect from fence placement or spectator activity

Note(s): Roadway chalked

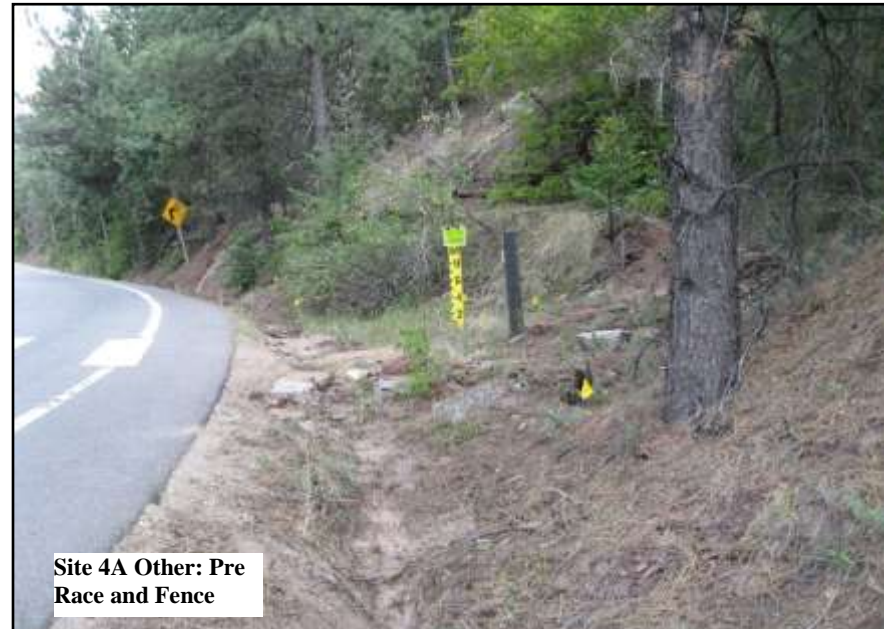
Site 4A Other: Pre  
Race and Fence

Results: No noticeable effect from fence placement or spectator activity

Note(s): Roadside viewing area

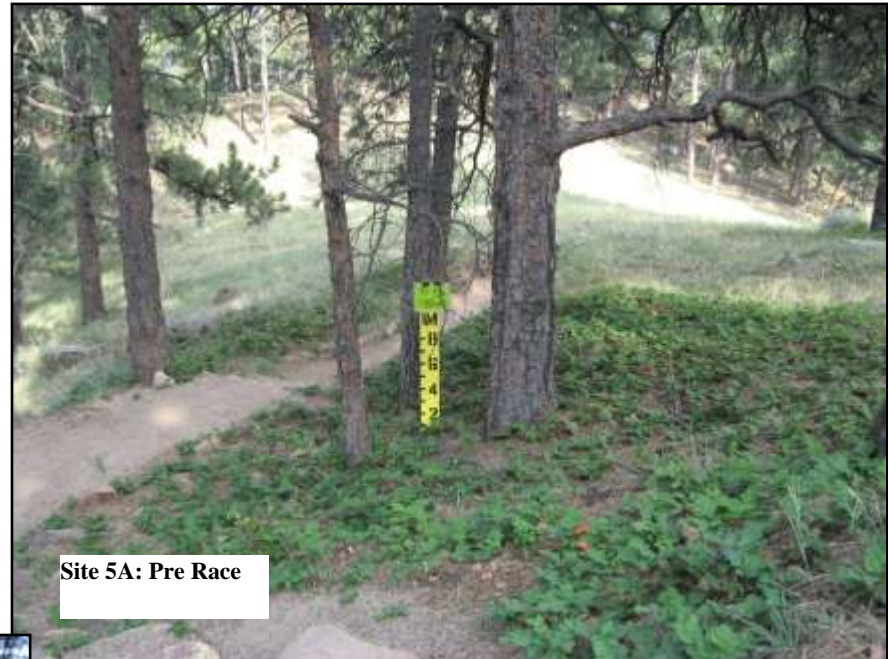
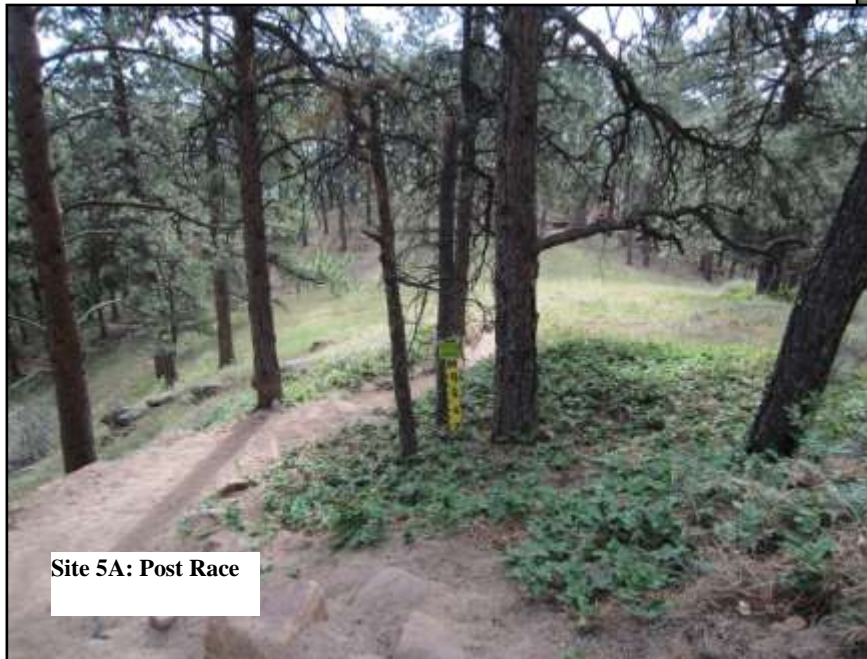
**2012 USA Pro-Cycle Challenge - Site ID 5A Center**

Results: No noticeable effect from spectator activity

- If monitoring is repeated, the following recommendations would improve the project's benefit, effectiveness and efficiency:
  - Eliminate photo points 1A, 5A, 8A, 8C, 10B, 11A, 15B and 19B. These are unlikely to show change in conditions because visitor travel off road or trail is already restricted by fence placement and trailside conditions or because terrain is resistant to visitor travel.

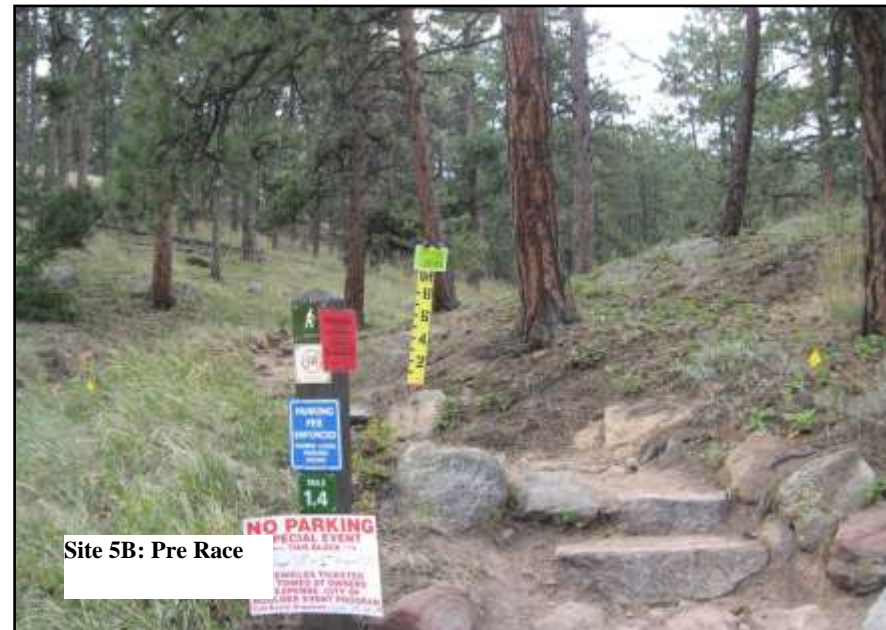
Site 5B: Pre Race

Results: Some noticeable change from fence placement or spectator activity

Note(s): Some vegetation loss and additional exposed soil

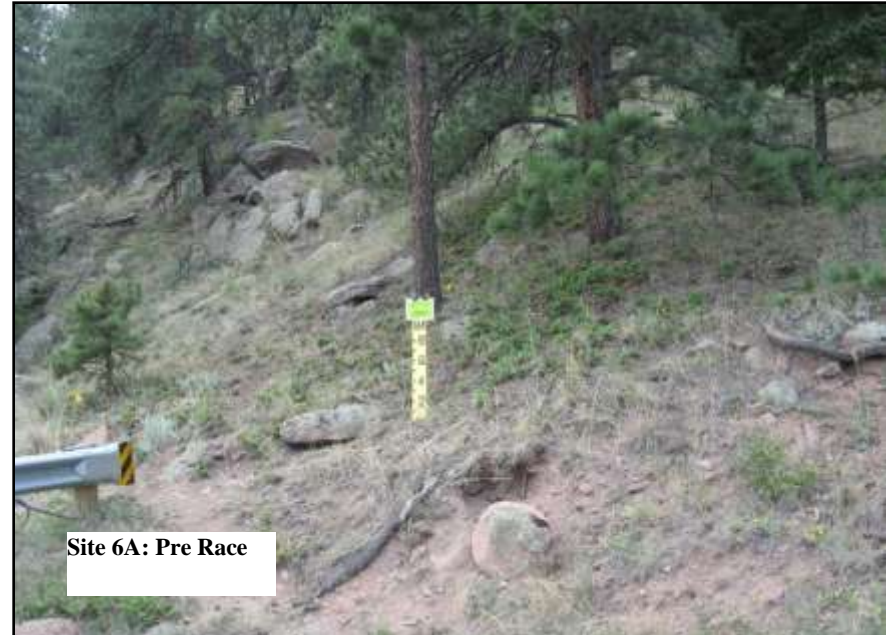
Site 6A: Pre Race

Results: Some noticeable change from fence placement or spectator activity

Note(s): Minor vegetation loss and additional exposed soil

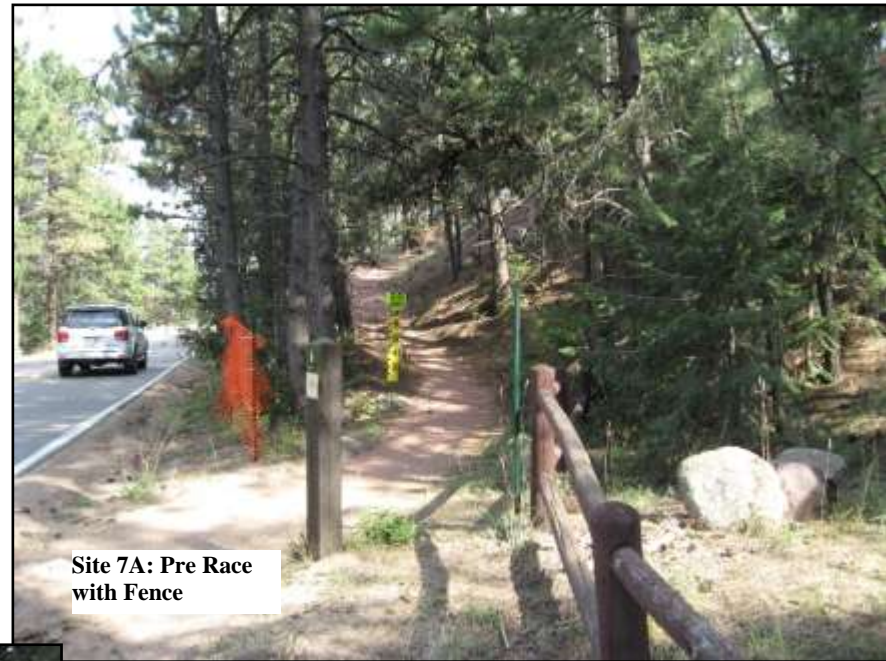
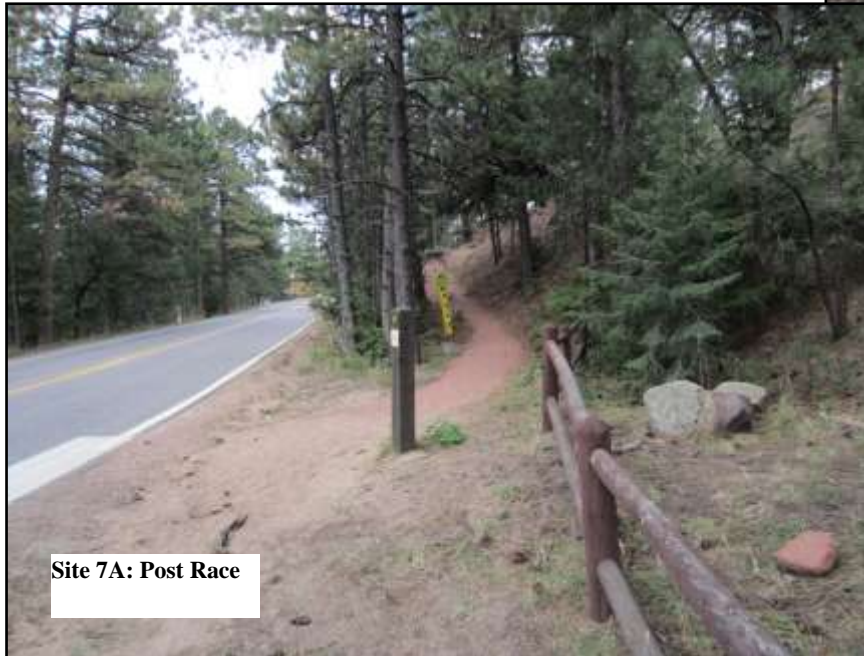
**2012 USA Pro-Cycle Challenge - Site ID 7A Center**

Results: Some noticeable change from fence placement or spectator activity

Note(s): Minor vegetation loss and additional exposed soil

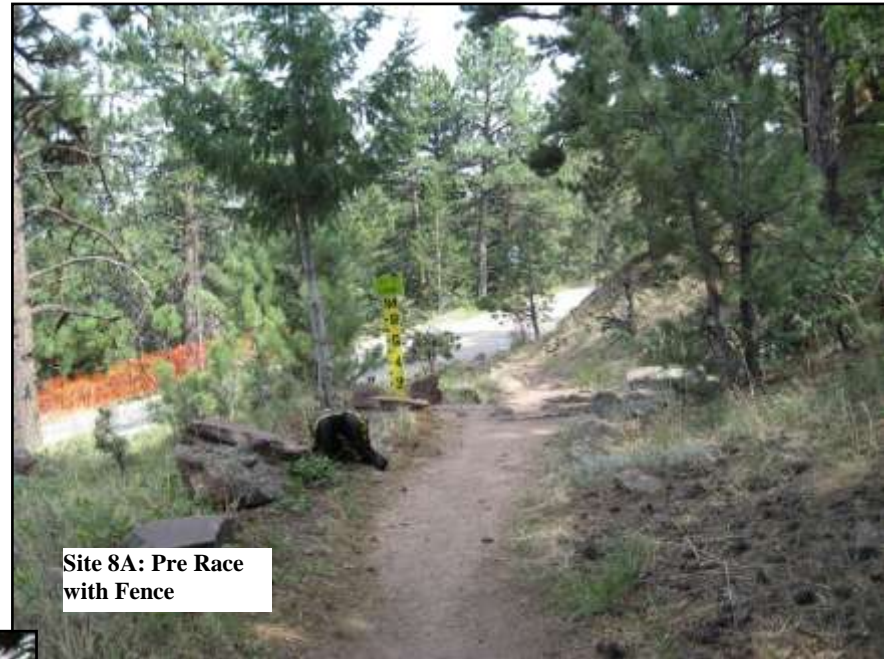
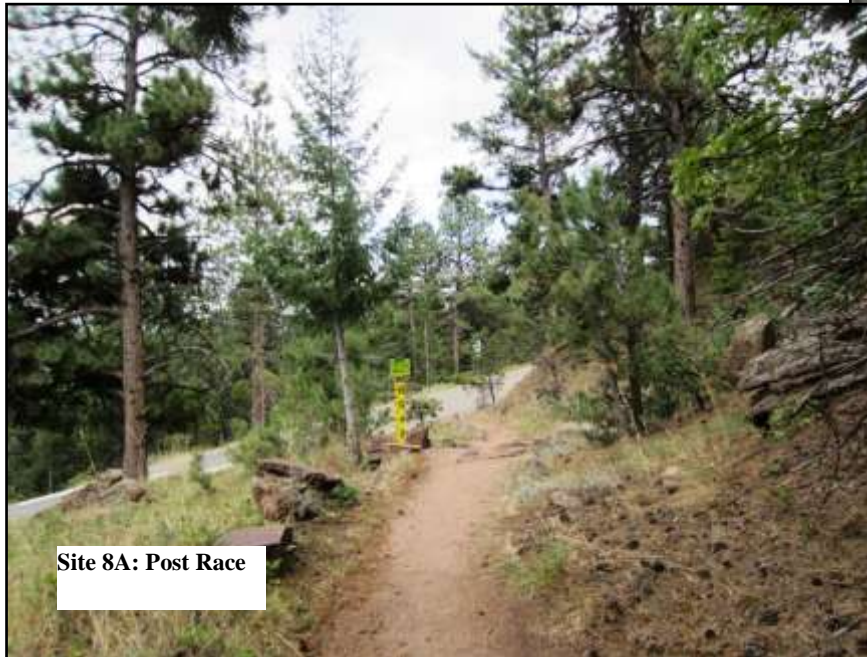
## **2012 USA Pro-Cycle Challenge - Site ID 8A Center**

Results: No noticeable effect from spectator activity

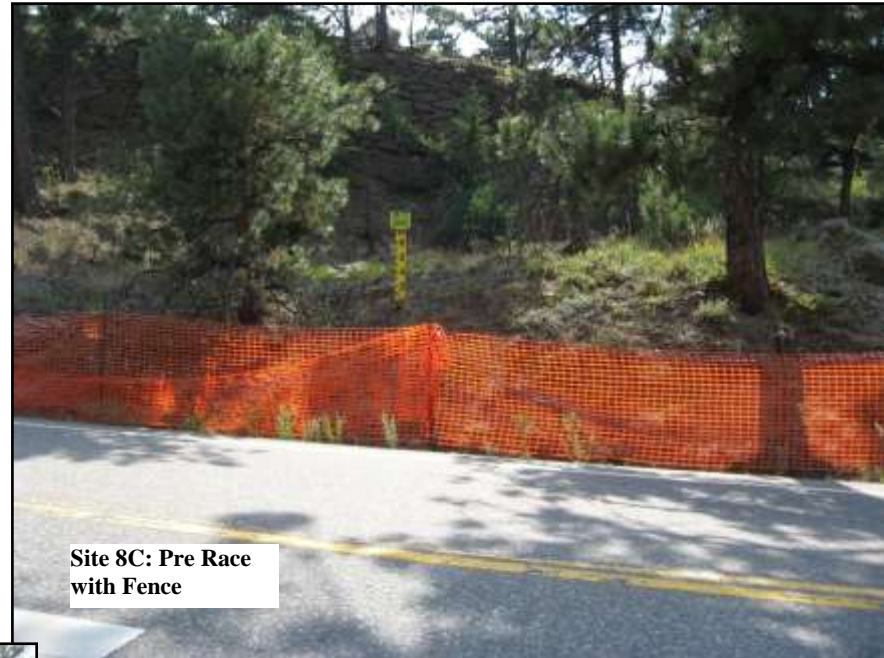
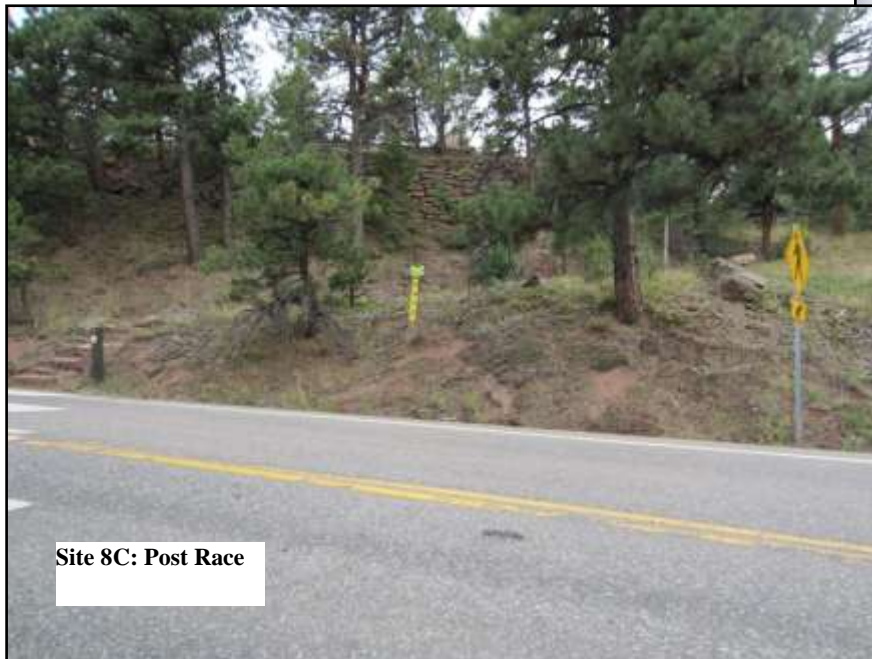
## **2012 USA Pro-Cycle Challenge - Site ID 8C Center**

Results: No noticeable effect from fence placement or spectator activity

Note(s): Roadside viewing area; fence installed before pre race photos taken

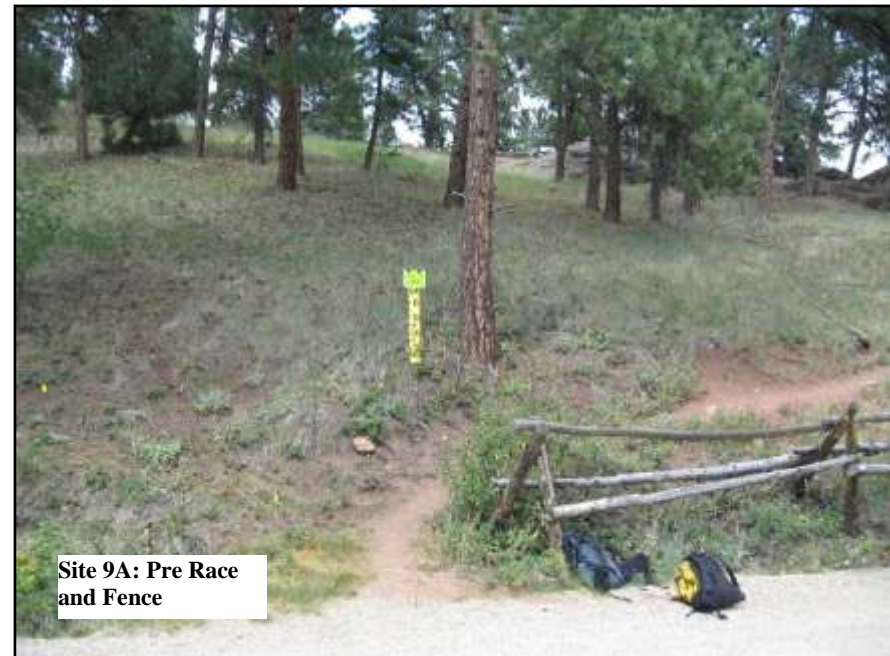
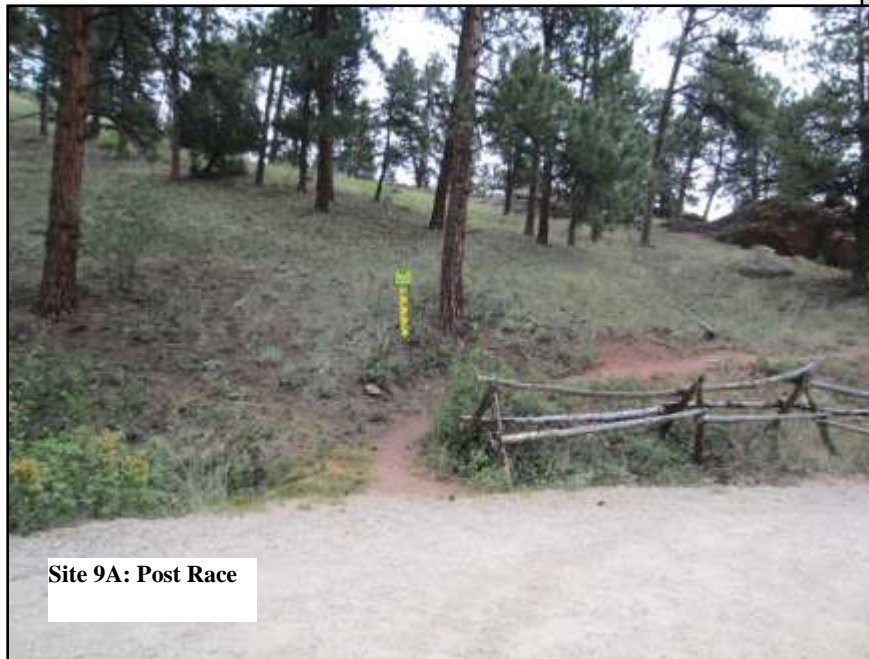
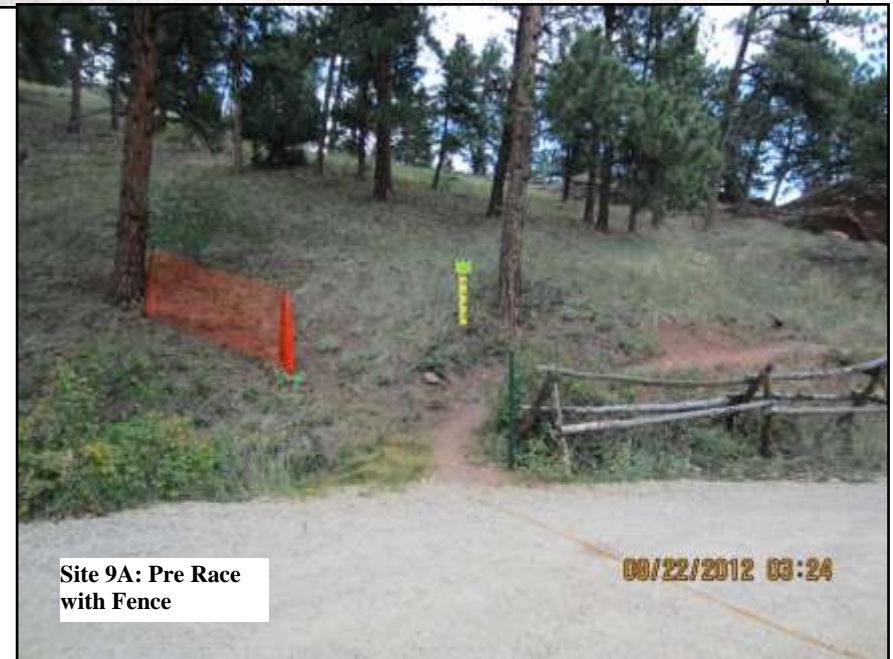
## 2012 USA Pro-Cycle Challenge - Site ID 9A Center

Results: No noticeable effect from fence placement or spectator activity

Note(s): Roadside viewing area

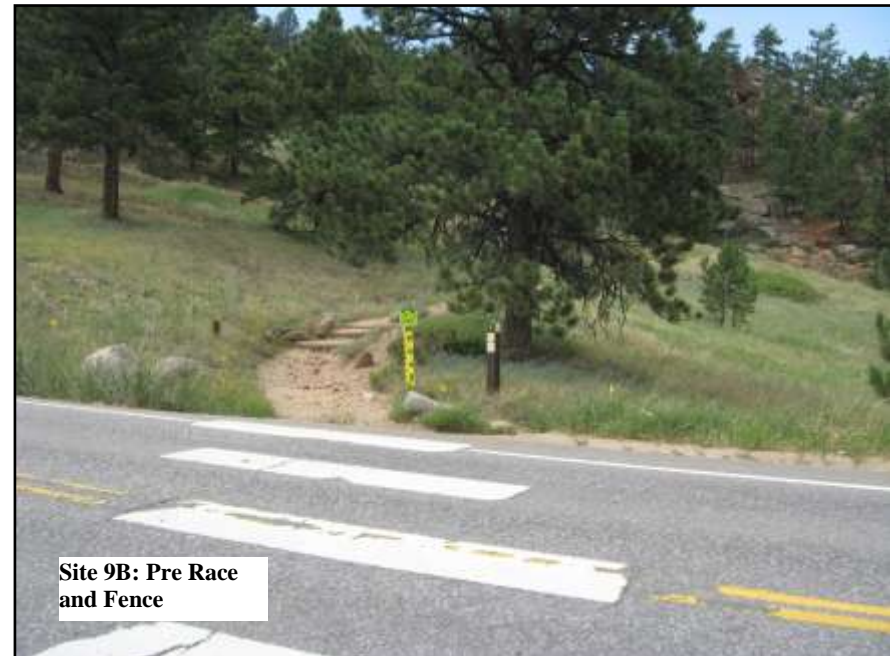
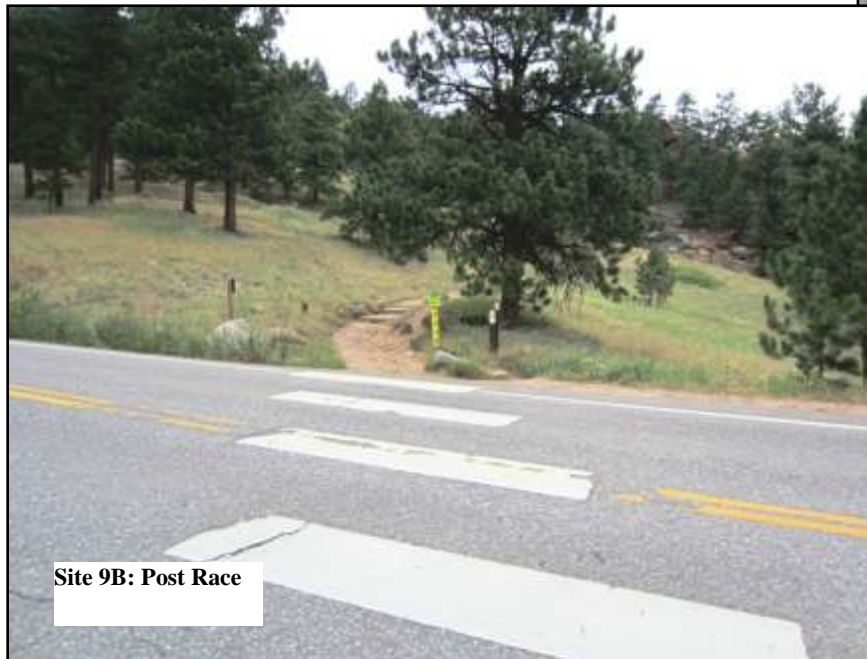
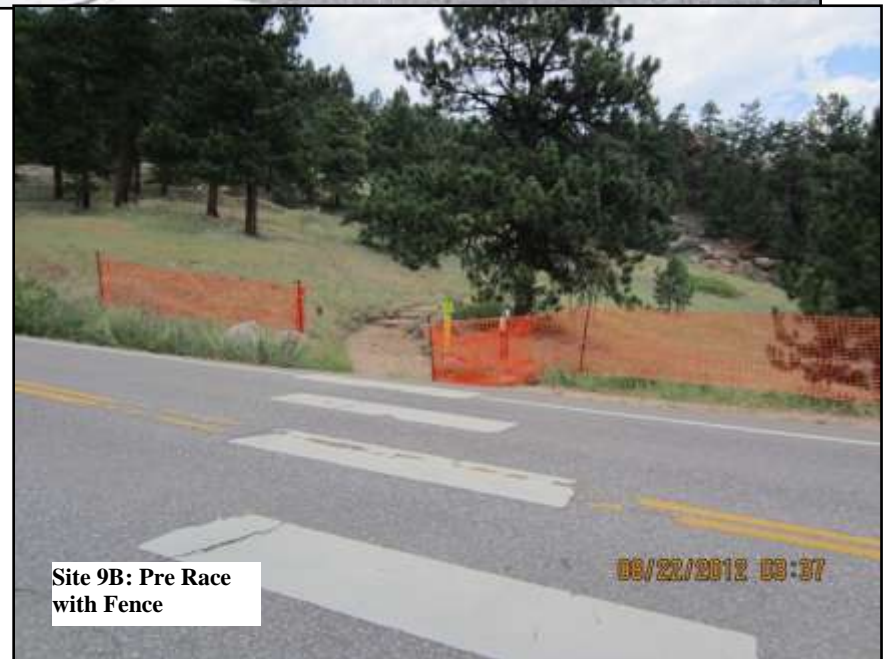
## 2012 USA Pro-Cycle Challenge - Site ID 9B Center

Results: No noticeable effect from fence placement or spectator activity

Note(s): Roadside viewing area

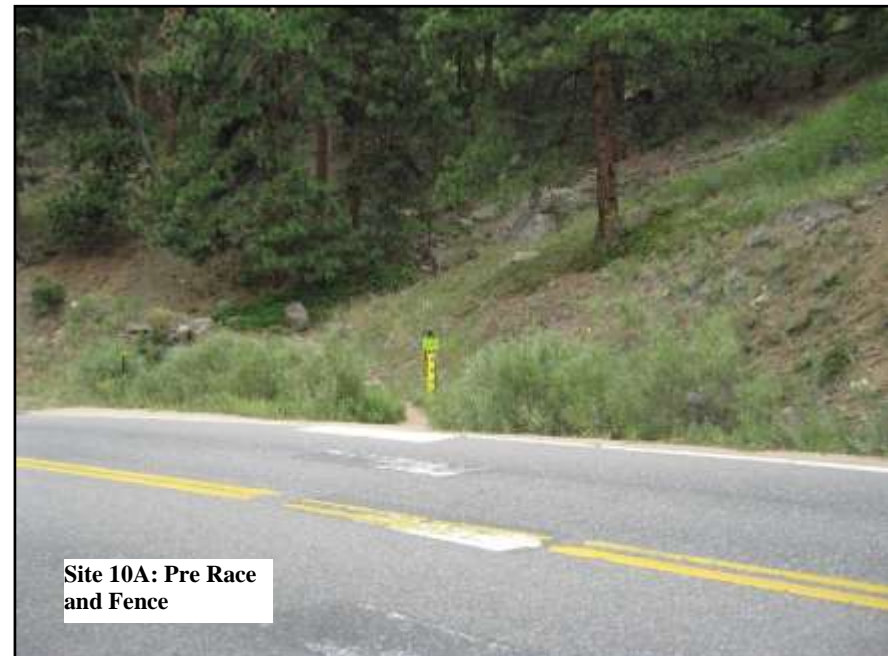
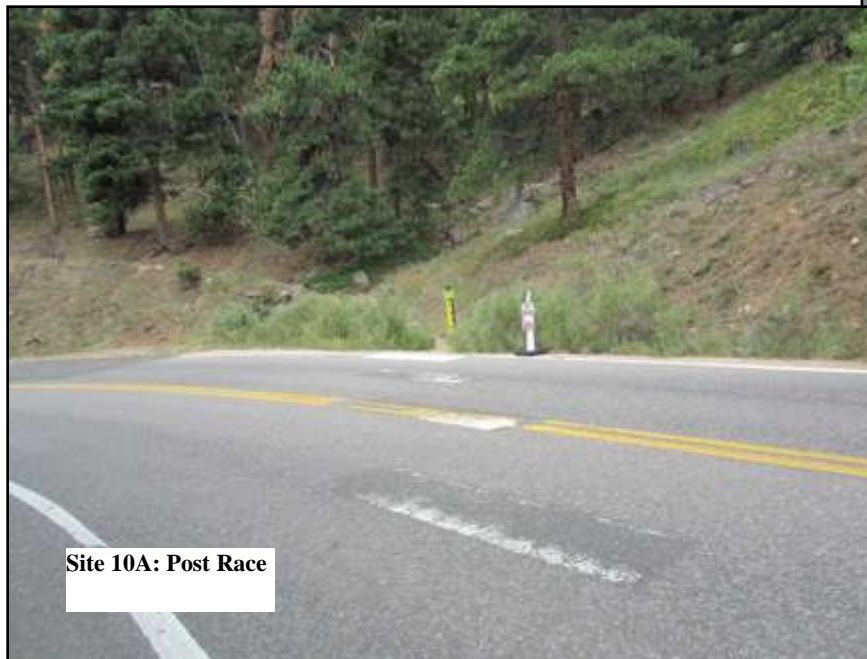
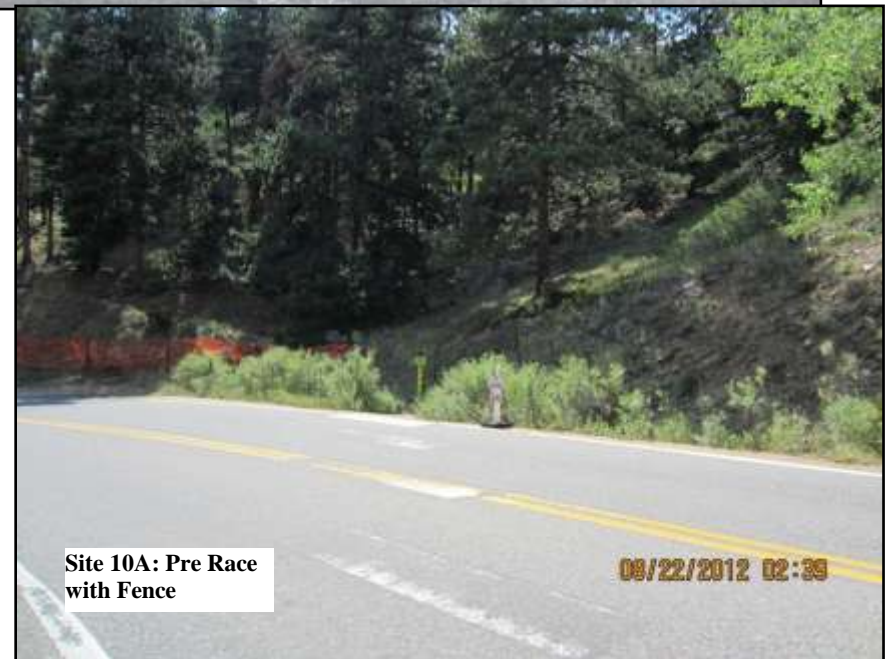
## 2012 USA Pro-Cycle Challenge - Site ID 10A Center

Results: No noticeable effect from fence placement or spectator activity

Note(s): Roadside viewing area

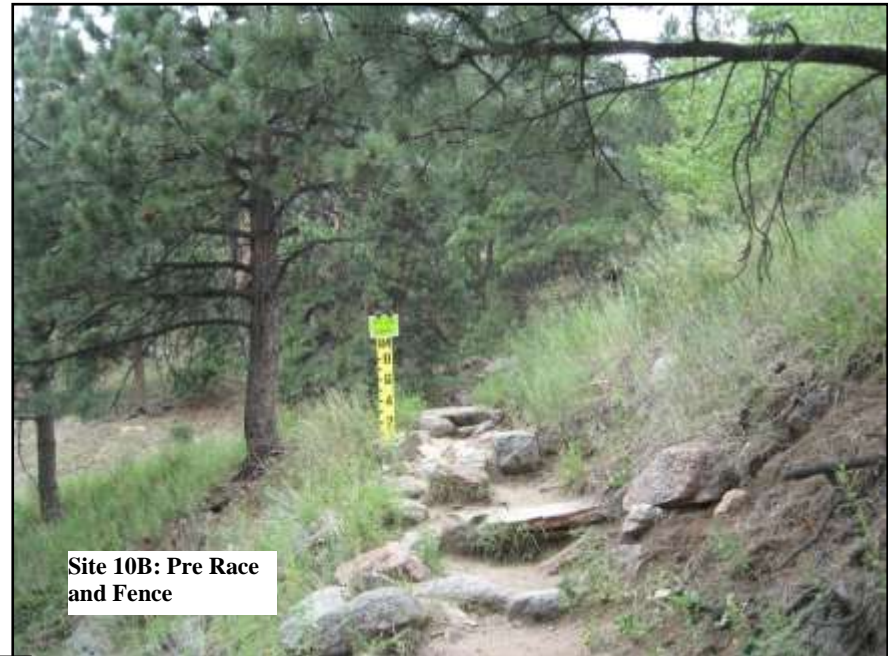
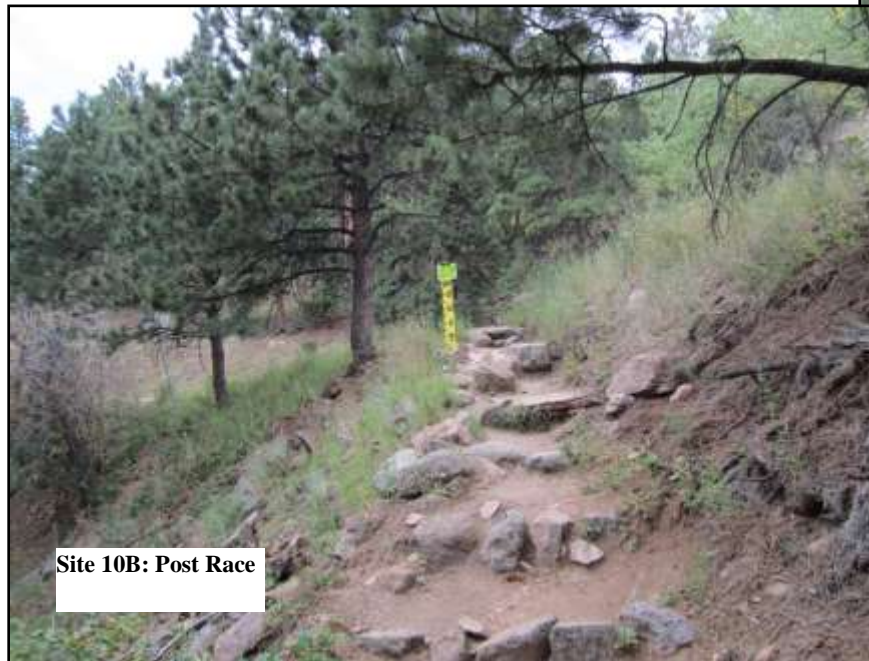
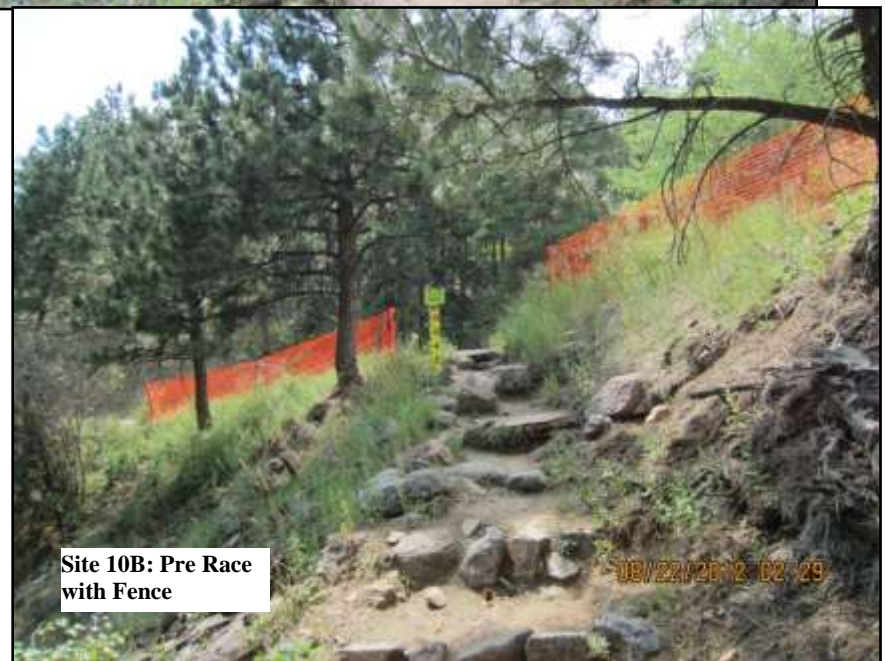
## 2012 USA Pro-Cycle Challenge - Site ID 10B Center

Results: No noticeable effect from fence placement or spectator activity

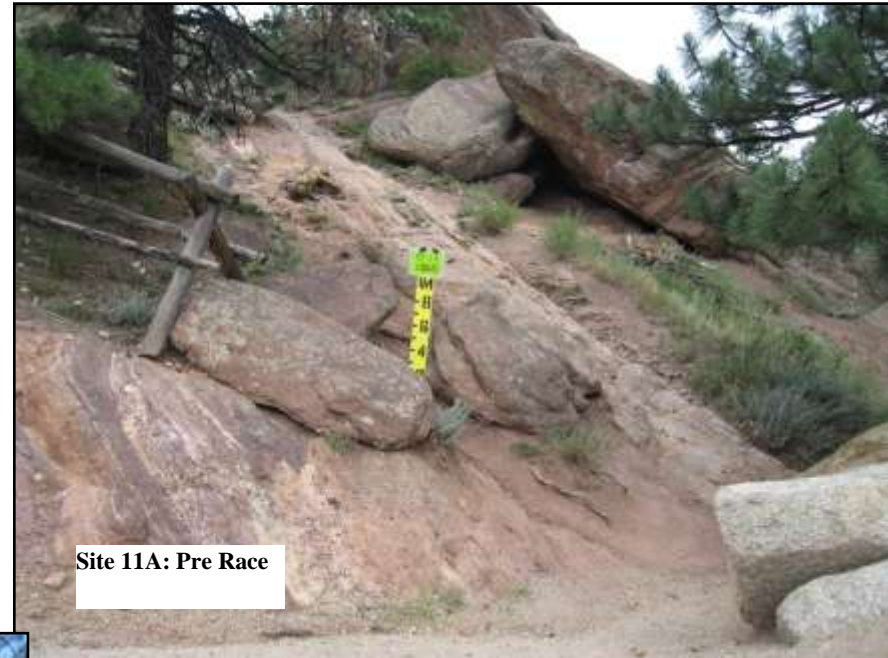
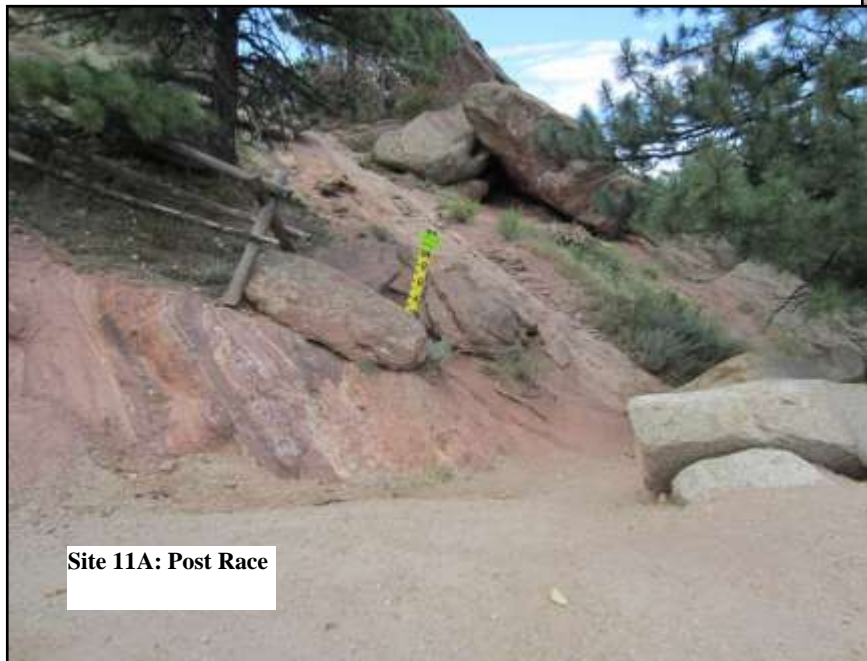
**2012 USA Pro-Cycle Challenge - Site ID 11A Center**

Results: No noticeable effect from spectator activity

Note(s): Roadside viewing area
